Manhole Inspection Summary

Manhole # S49A__032MH

Insp Date: **3/23/09 3:45 PM**

Location Address: **2532 ORLEANS ST**

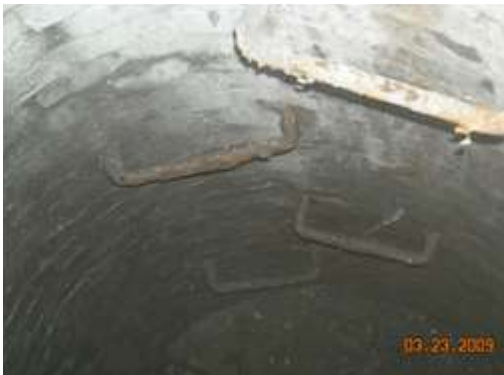
Defect 5

Steps Count: **4** Missing: **0** ☒ **Corroded**

CORRODED STEPS

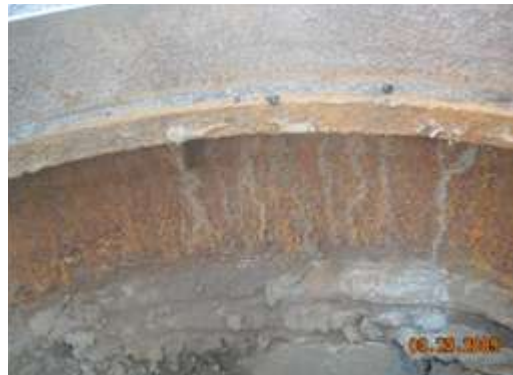
Defect 4

Frame Offset: **2.5** (in.) Condition: ☐ Sound ☐ Cracked ☒ **Leaks**

FRAME LEAKS

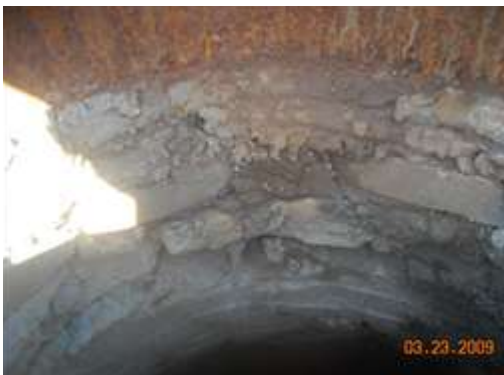
Defect 3

Condition: ☐ Sound ☐ Cracked ☐ Root Intrusion ☐ Loose Brick ☒ **Deteriorated**

Infiltration: ☐ None ☒ **Joint** ☐ Cracks ☐ Mortar ☐ Roots ☐ Wall

INFILTRATION @ CHIMNEY/FRAME JOINT, DETERIORATING CHIMNEY

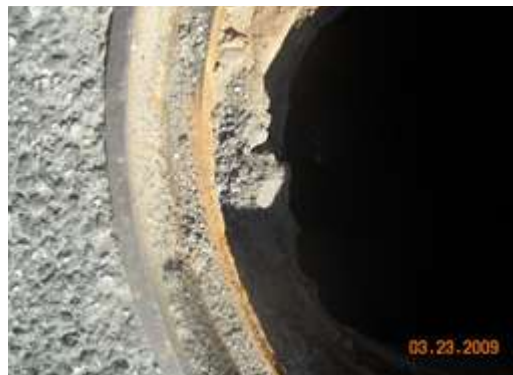
Defect 2

FRAME OFFSET

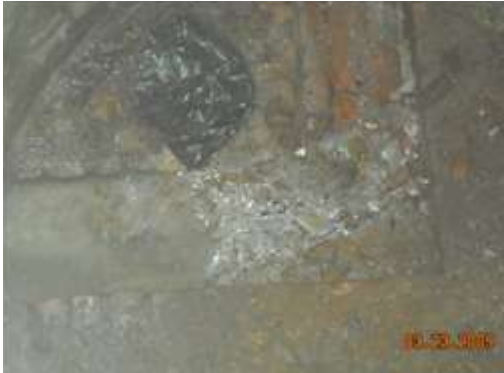
Defect 1

Condition: ☐ Sound ☐ Cracked ☐ Root Intrusion ☐ Deteriorated ☐ Leaks ☒ **Debris**

DEBRIS IN CHANNEL AND BENCH

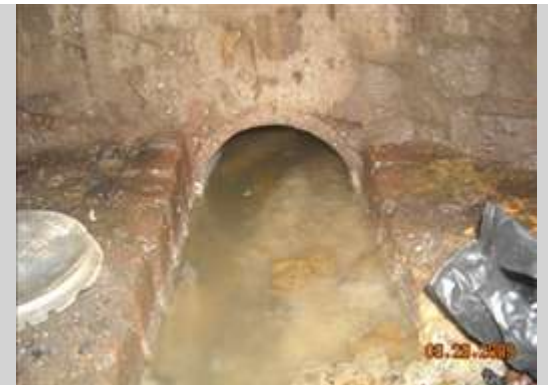
9 O'Clock Inflow

Pipe Height: **8.4** (in.) Rod and Bar (Angled)
Pipe Material: **Clay** ☐ Pipe Lined
Invert Depth: **8.43** (ft.) Flow Characteristics: **Slow**
Deposits: ☐ None ☐ Mud ☒ **Sludgy** ☐ Debris ☒ Grease
Silt Depth: **3** (in.) Deposits Extent: **Medium**
Infiltration: **None** Pipe Seal Cond: **Sound**
